Historical use revealed by salt marsh impairments informs new restoration approaches

University of
New Hampshire

Coastal Habitat
Restoration Team

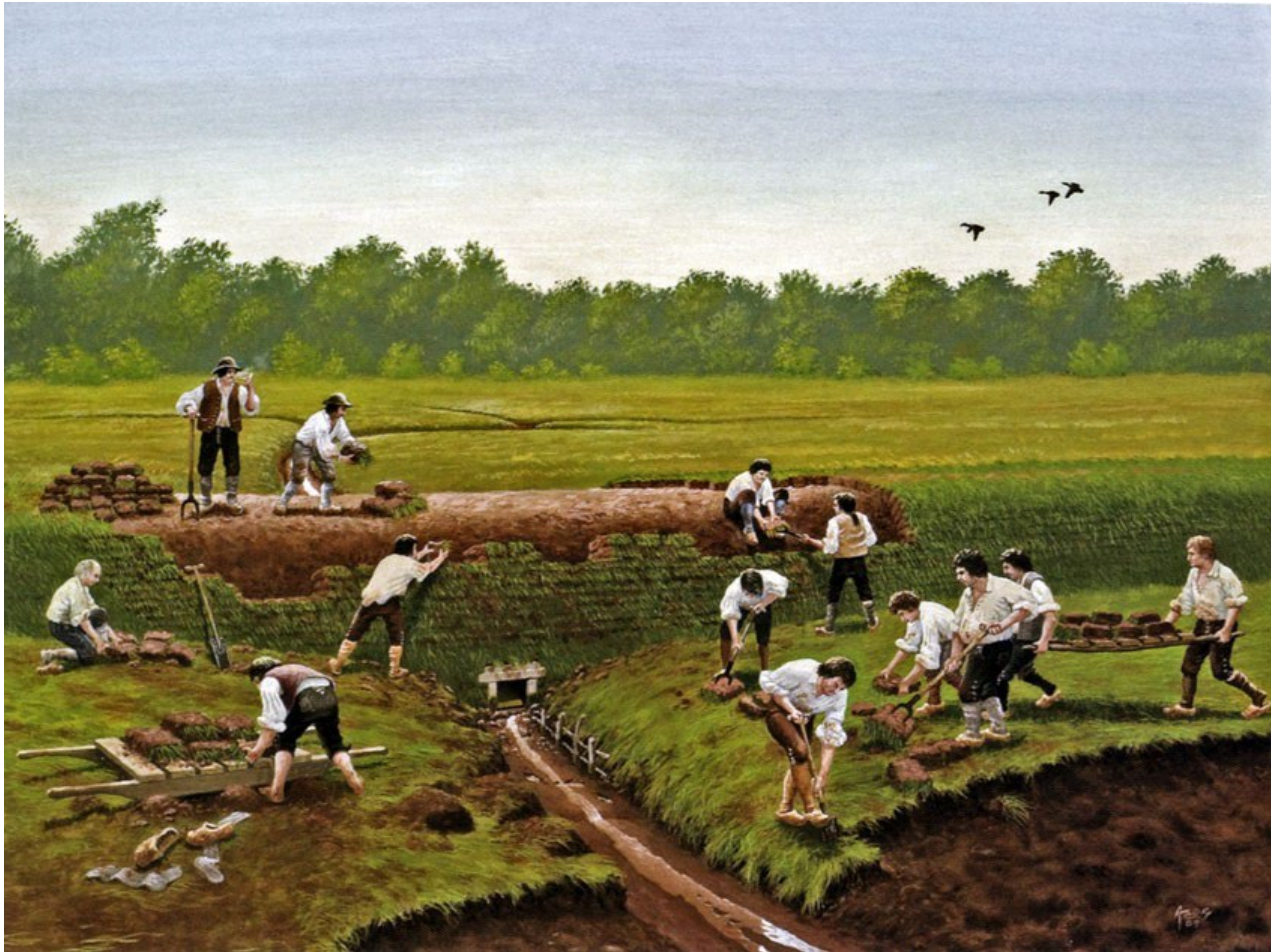
"Repairing a dyke" c. 1720 by Azor Vienneau;
Nova Scotia Museum, Accession number 87.120.2

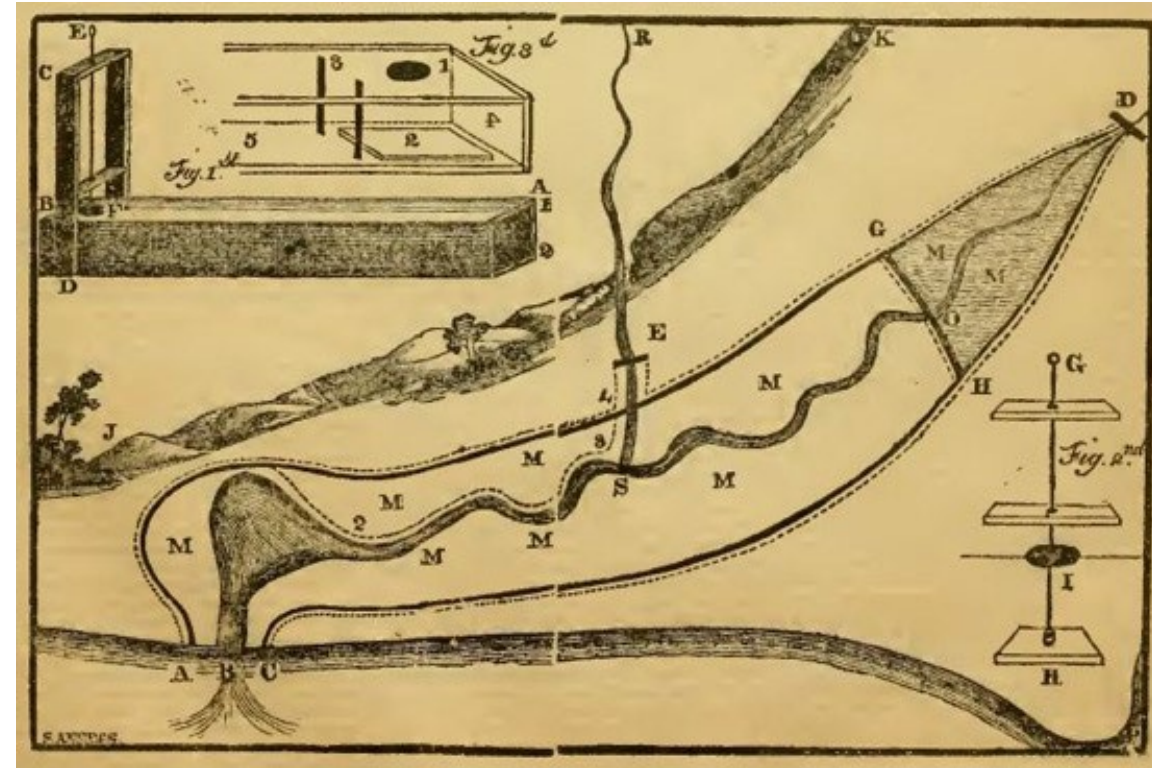
American Farmer – 1824 Detailed
infrastructure 'blueprints' for farming tidal
marshes

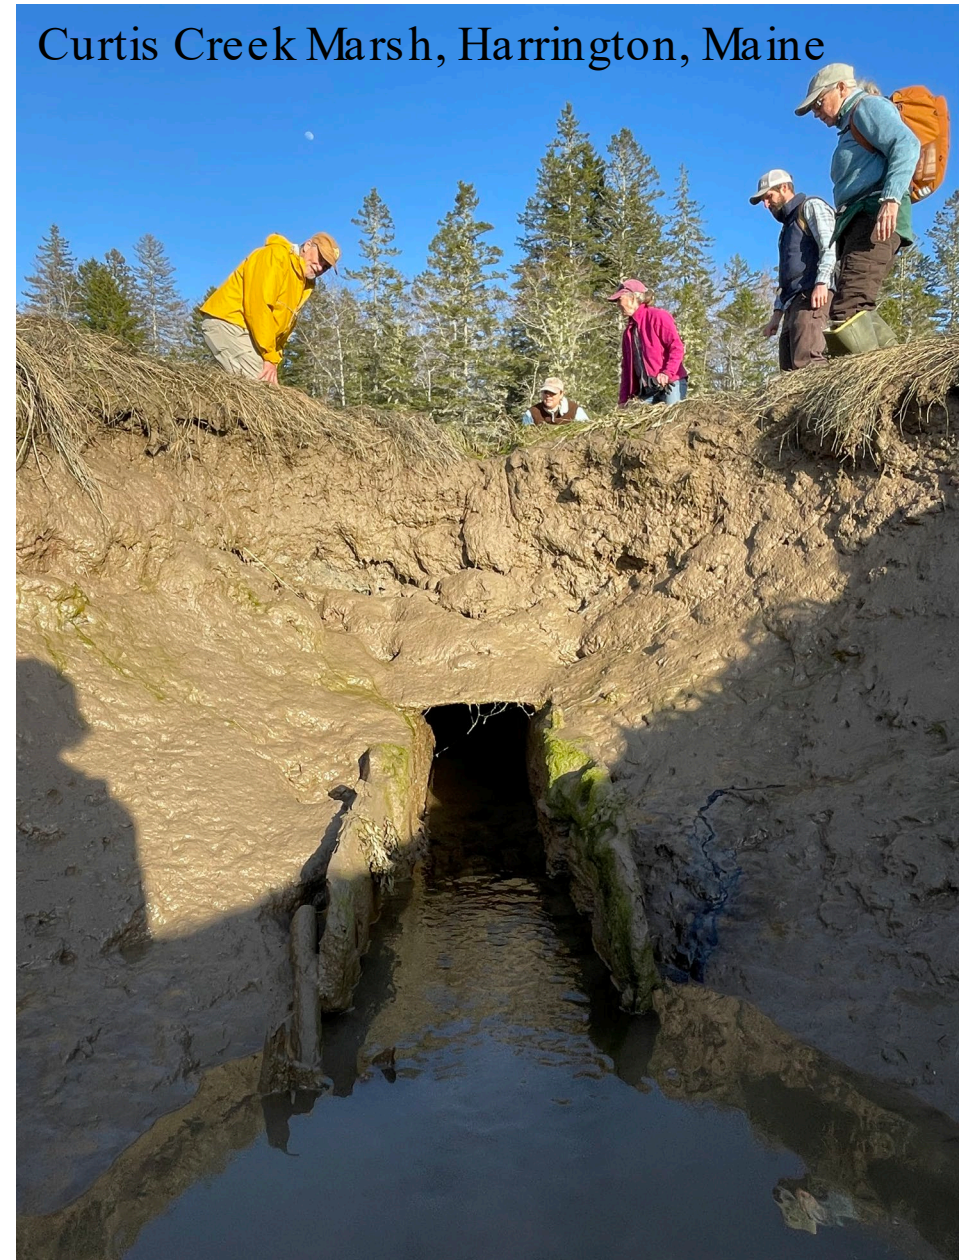
Curtis Creek Marsh, Harrington, Maine

... and what is left

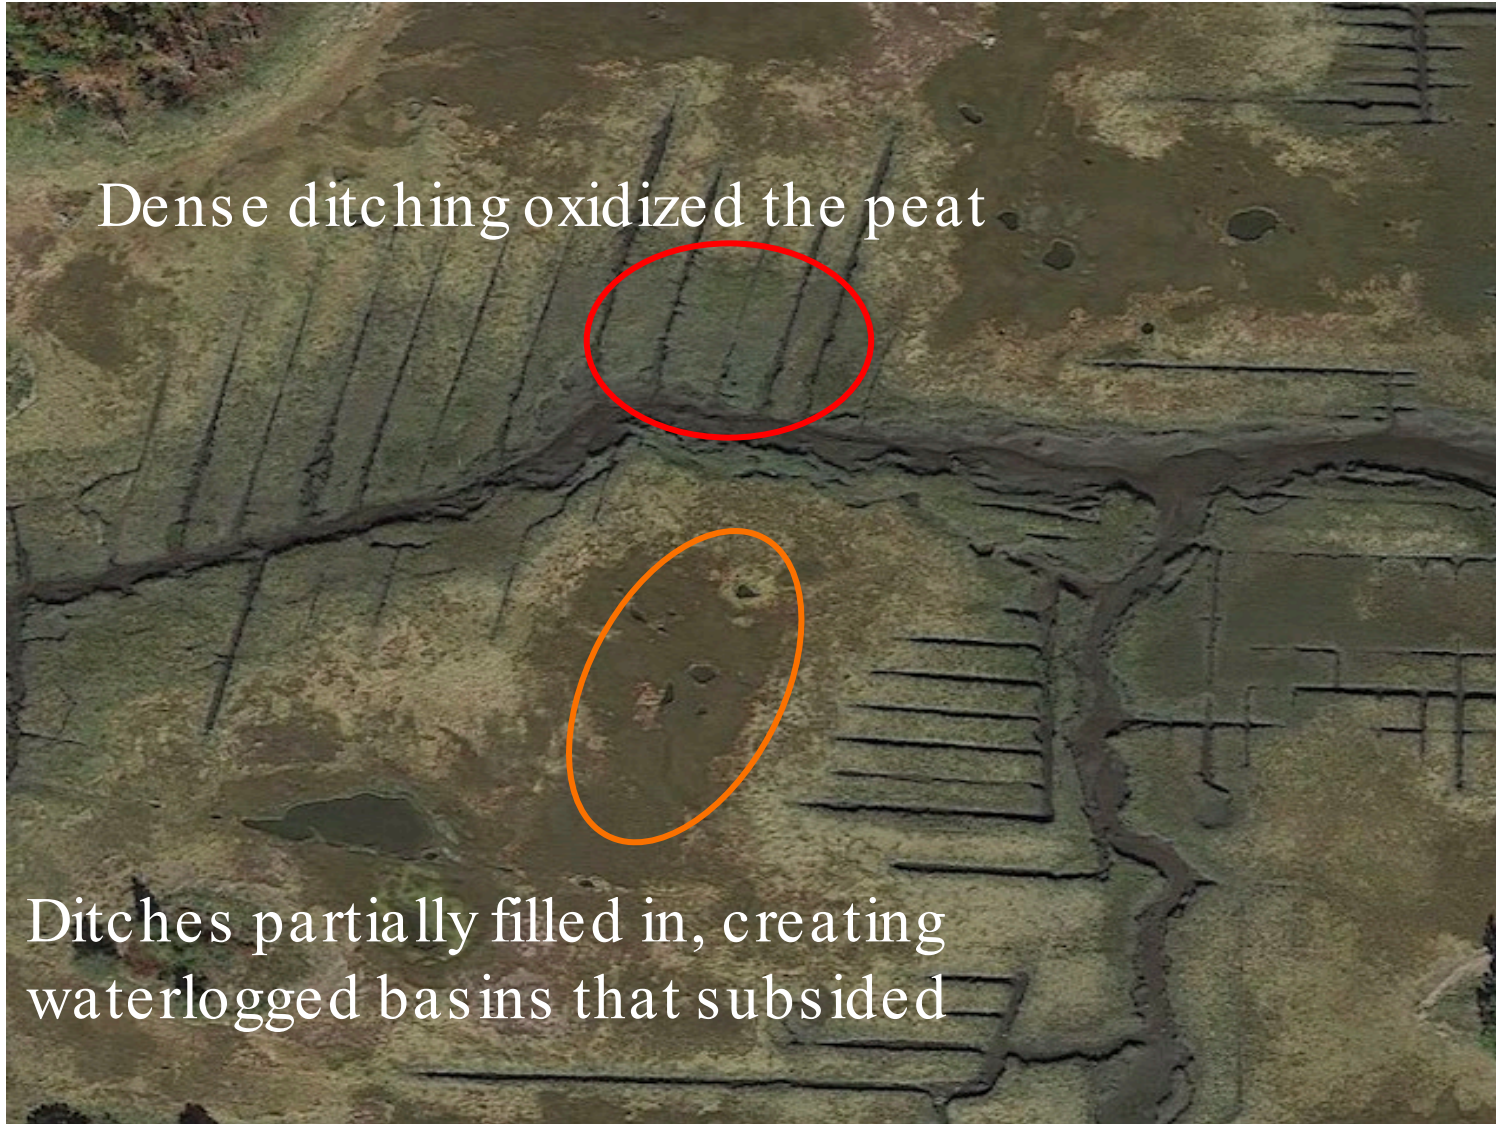
- Embankments settled into the growing peat
- Ditches filled (parallel hydrology was more than nature needed to fill and drain the tides)

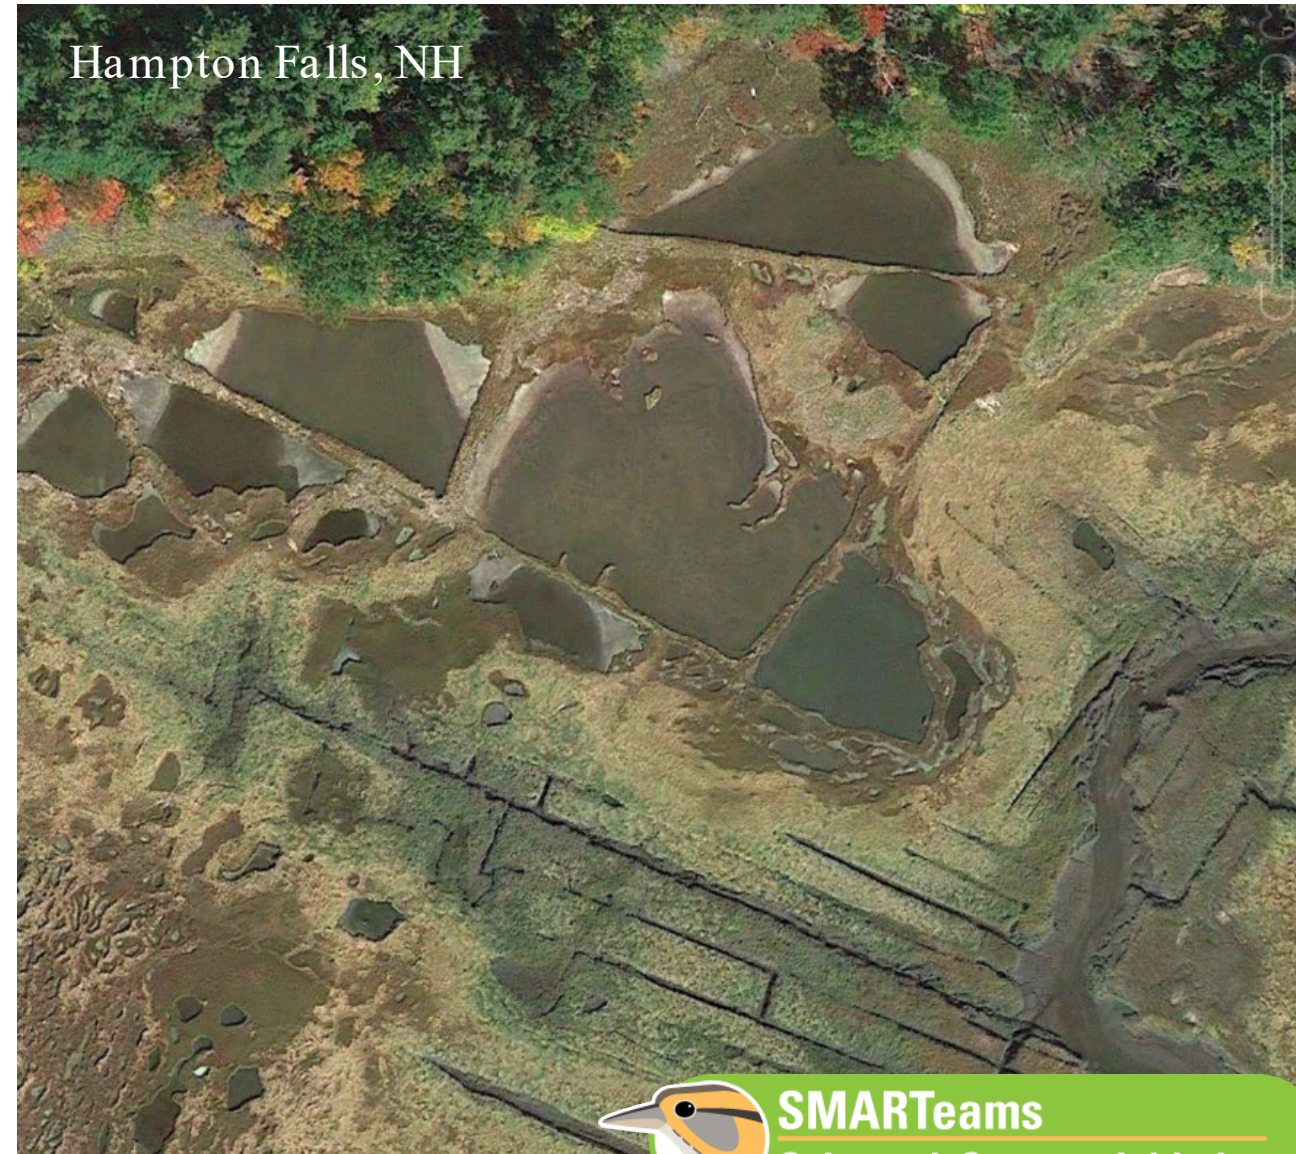
Embankments and ditches - legacy effects of agriculture interacting with greater rates of Sea Level Rise:

Ditches lower water tables and allow oxygen to convert peat to CO₂ (elevation falls) marshes become more susceptible to drowning

Embankments from farming and ditch spoils hold water on the marsh, leading to plant die-off, mega-pools and elevation loss

Loss of marsh elevation is caused by Ditching AND Embankments

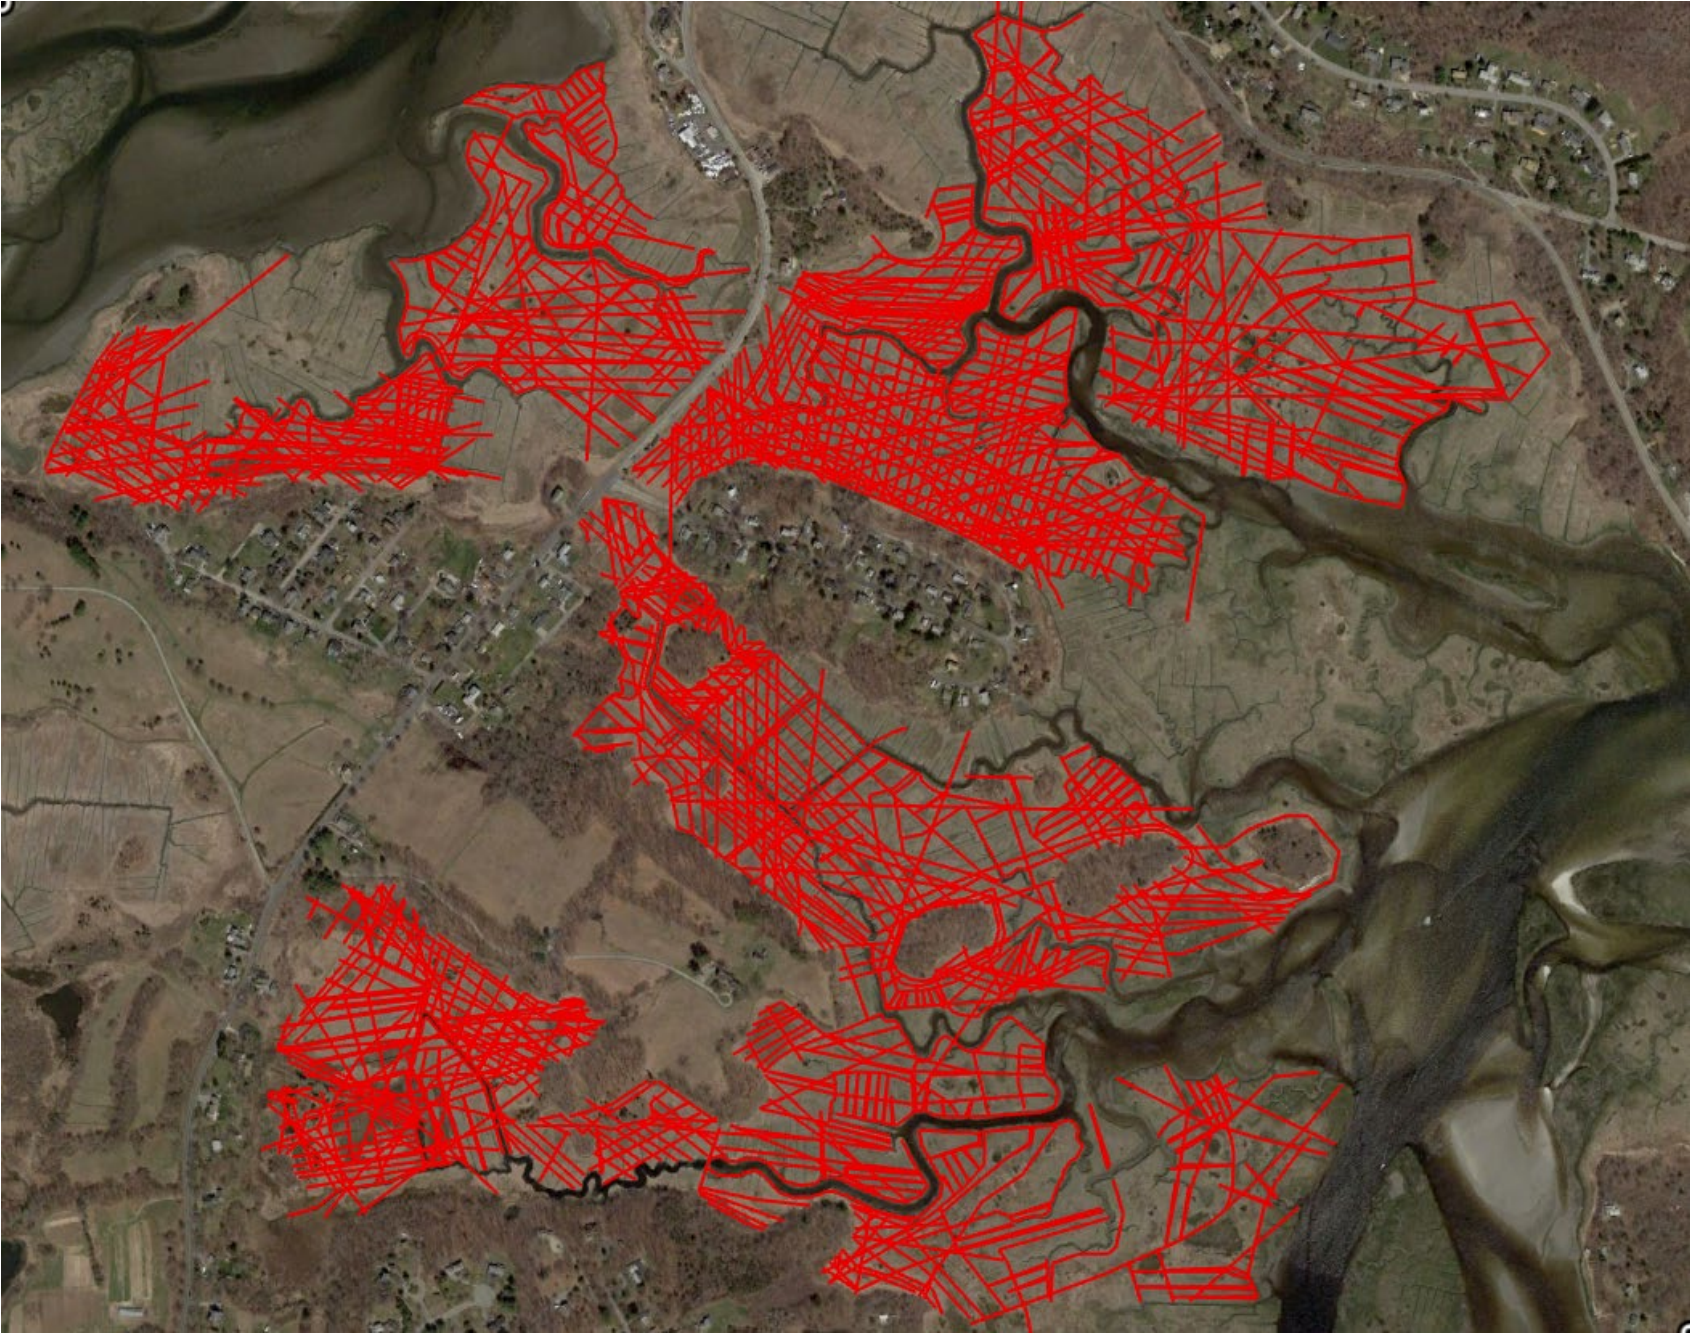
Jeffrey's Neck Work Unit

- 1,044 Agricultural Embankments Identified

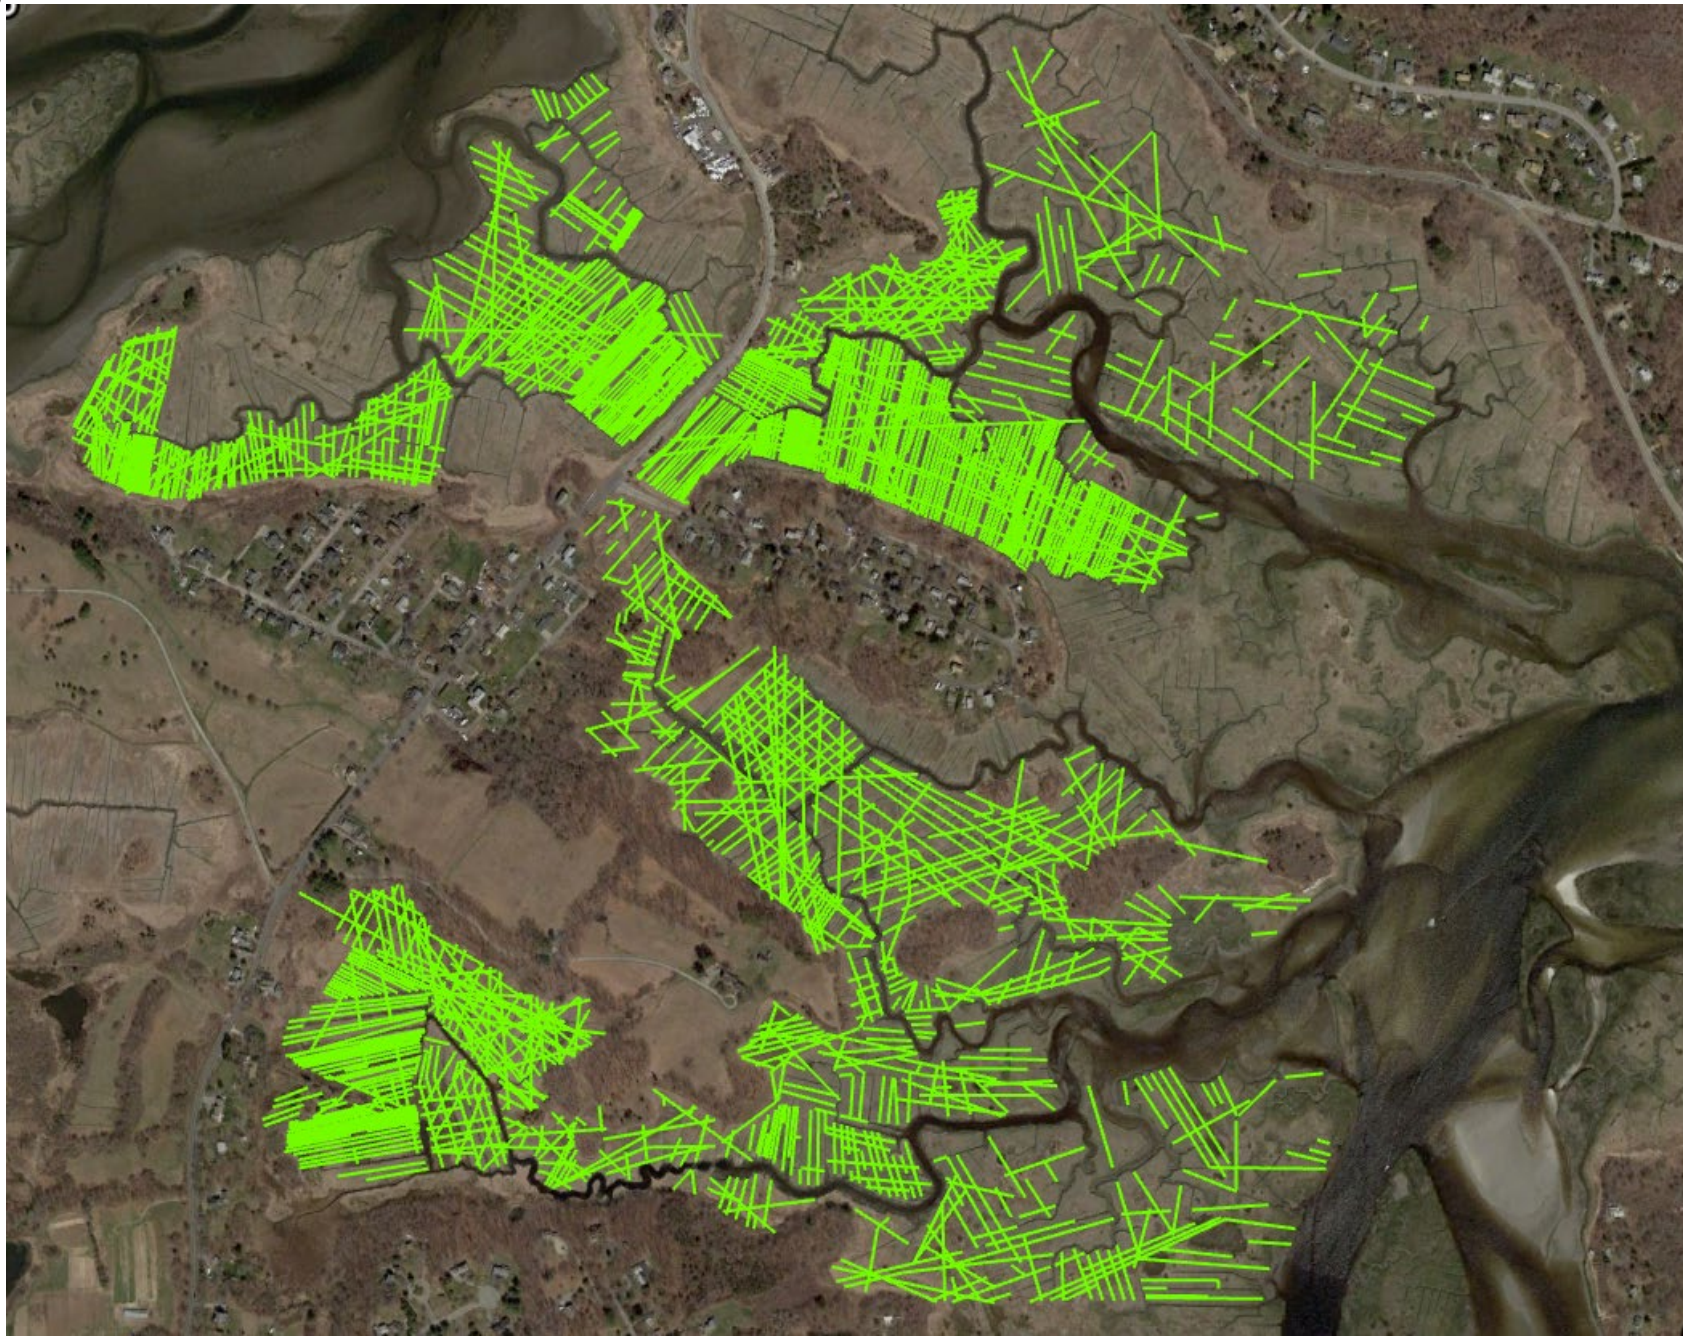
Jeffrey's Neck Work Unit

- 294-Acres
- 7 Properties
- 1,319 Remediation Ditches

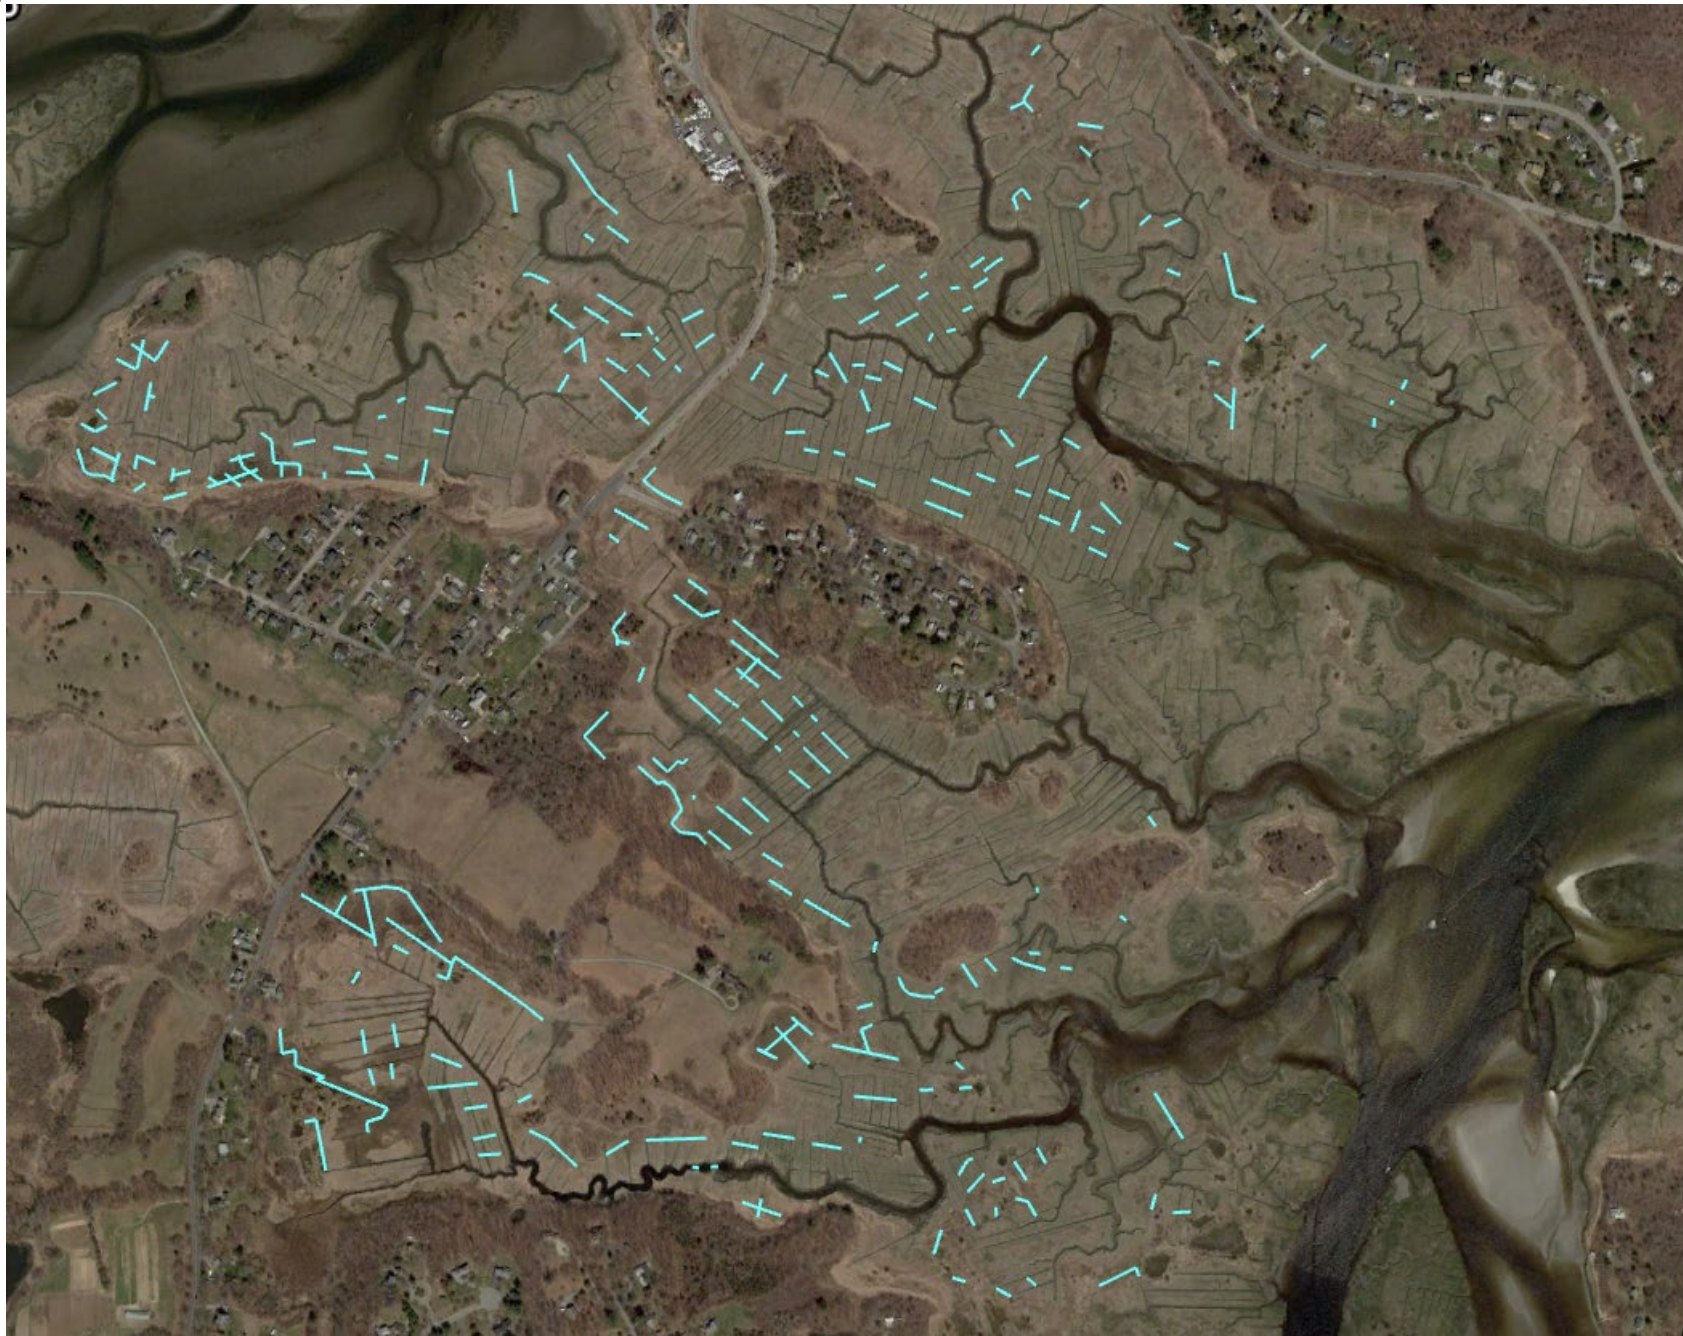
Jeffrey's Neck Work Unit

- 228 Runnels Within Existing Hydrological Pathways

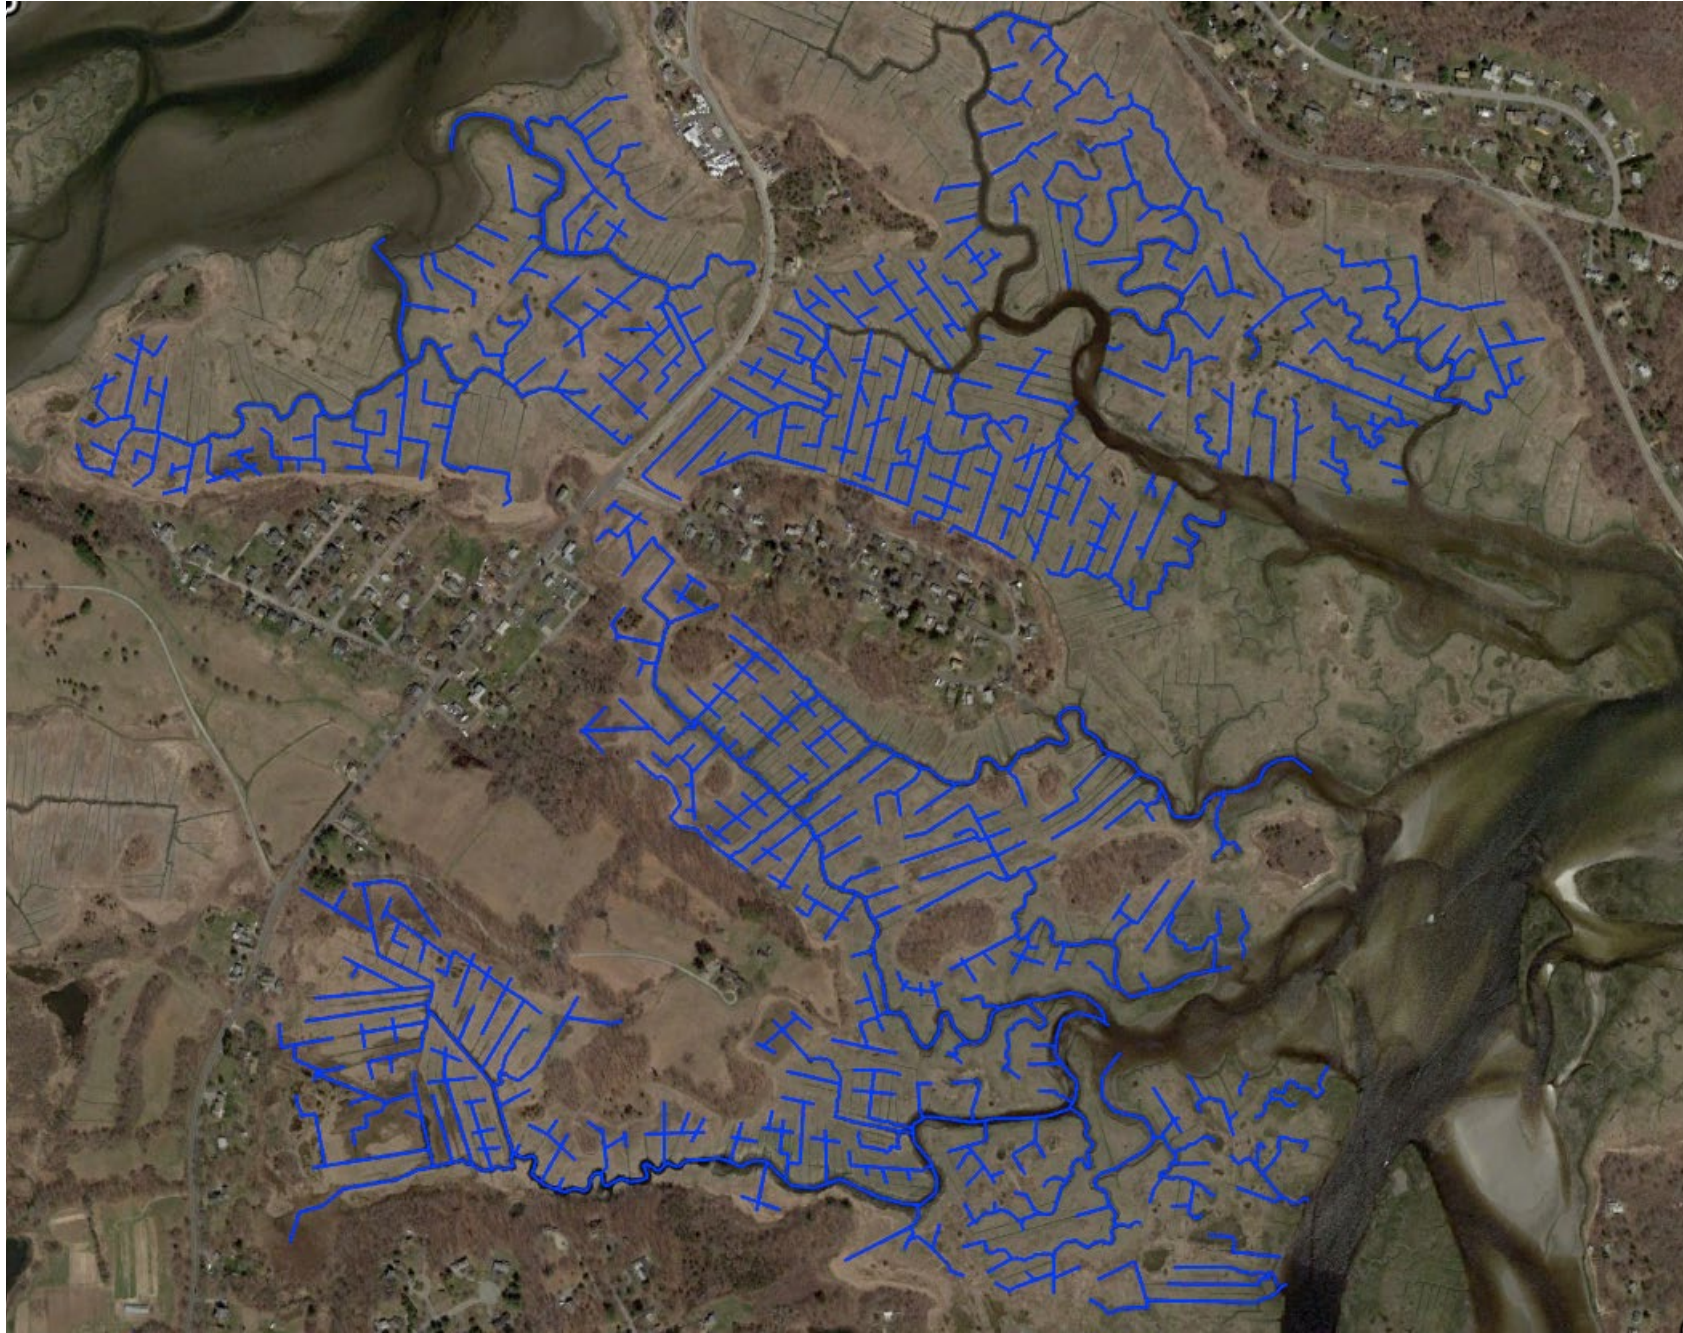
Jeffrey's Neck Work Unit

- 294-Acres
- 7 Properties
- 588 Tidal Channel Networks Restored Within the Existing Agricultural Infrastructure

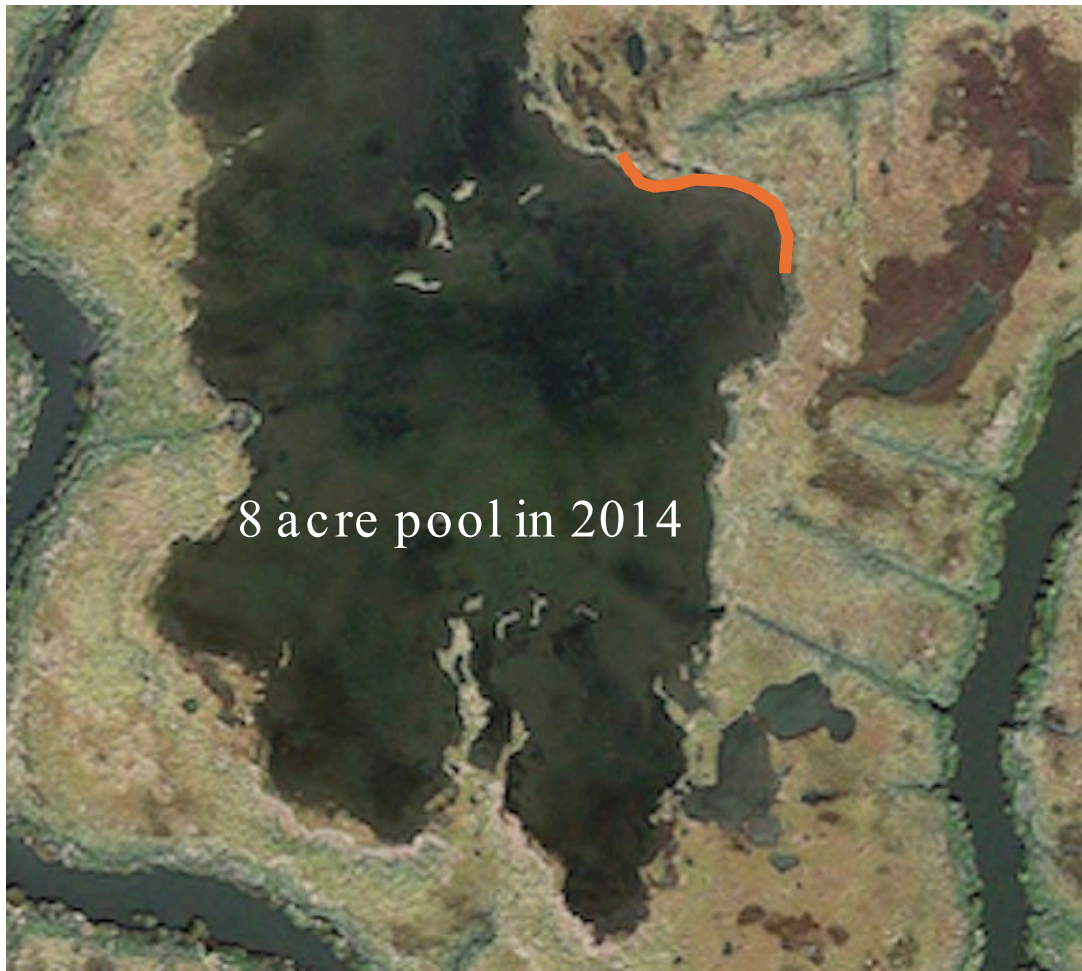
8 acre pool in 2014

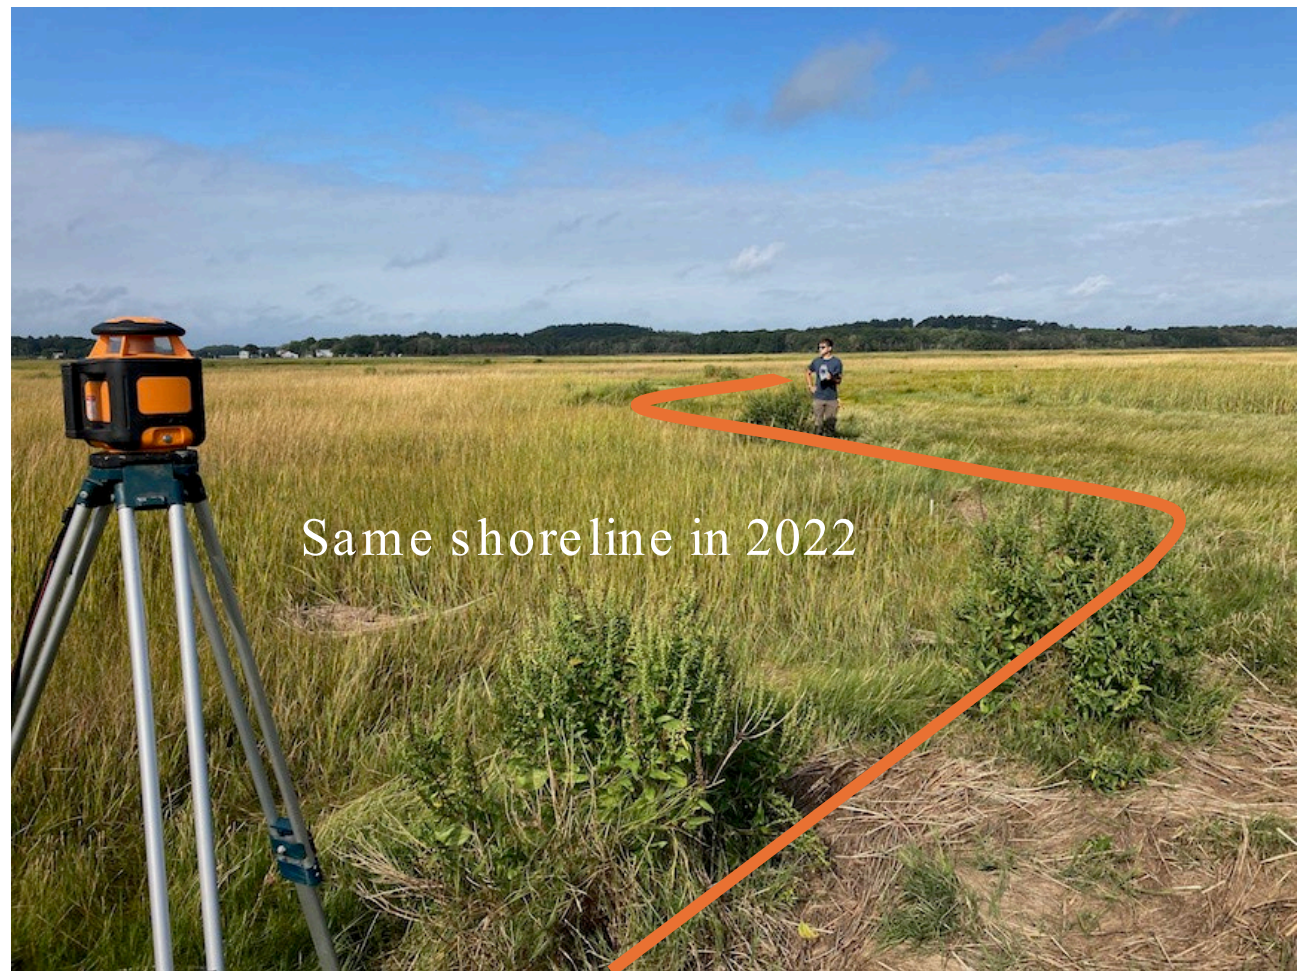
Same shoreline in 2022
